Roofing Inspection

Orion Home Improvements
 8404 Harland Dr.
 Springfield, VA 22152
 Phone (703) 926-9824
Jd Davies.roofing@gmail.com

Hollinger Ave. Fairfax, VA 22033	CUSTOMER NAME	Home: Work: Email:
-------------------------------------	----------------------	--------------------------

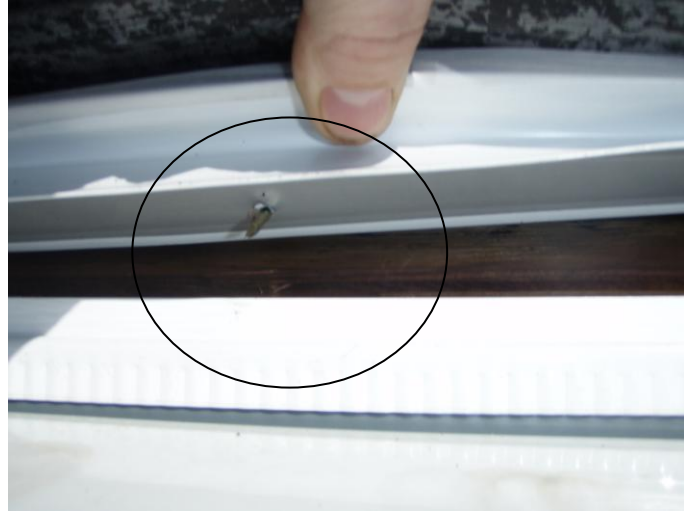
2. Drip edge is loose and nails are not secure. (PG 43 SLFG) Requires nails placed 8"-10" and secure.

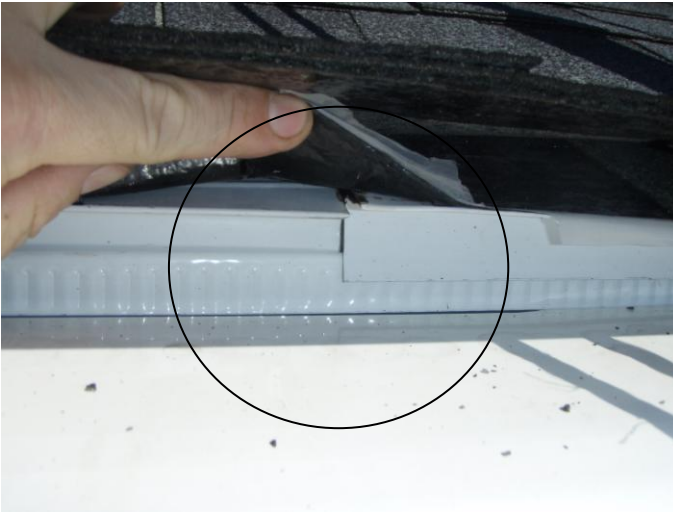
2. Drip edge mis aligned

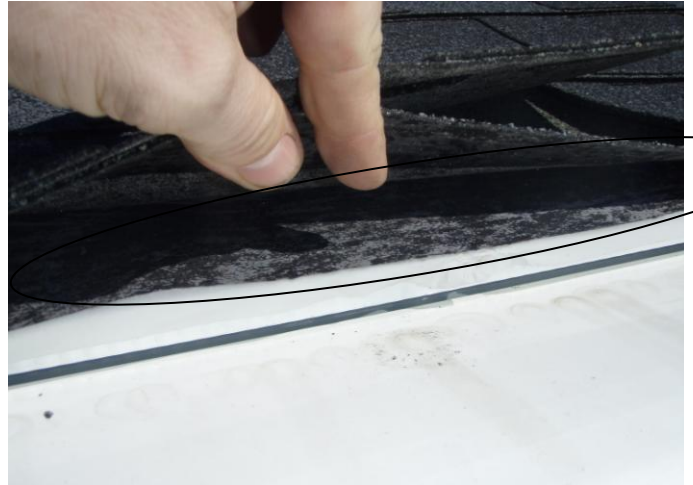
3. Selvage edge (Smooth plastic stripping) of leak barrier installed on downslope side. (pg 50 SLFG) Requires selvage edge along upslope side of roof.

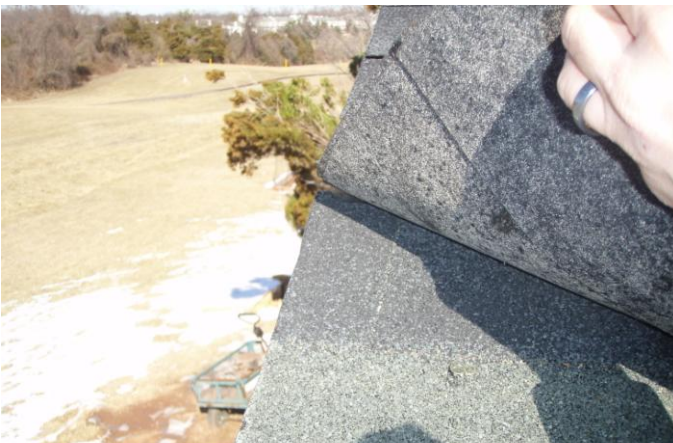
4. Standard field shingles used as starter shingles without being trimmed to fit and nailed to far from the eave edge. (PG 180 SLFG) Requires either starter shingles or hand cut starter trimmed to 6".

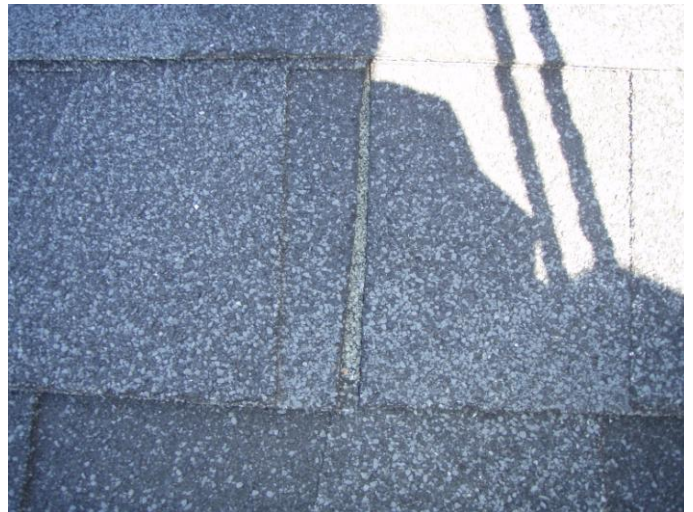
5. Close up of mis aligned course and gap at butt joint of shingles.

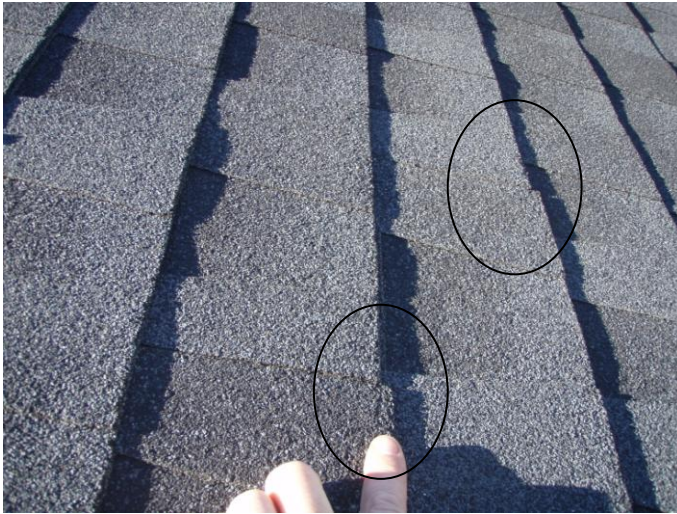
5. Courses with mis alignment off sets

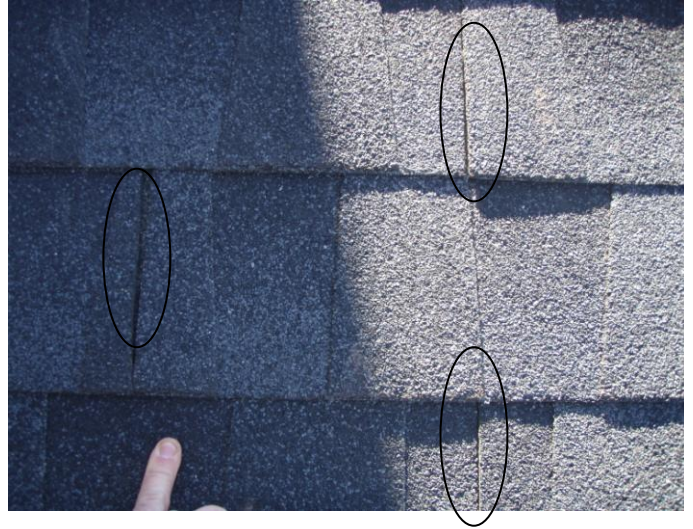
6. Shingle butt joints "racked" with improper offset. (PG 185 SLFG) requires 4 course offset

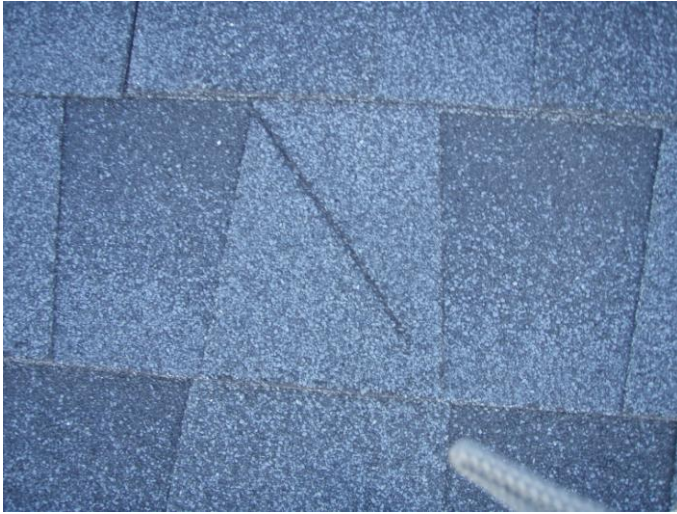
7. Shingles have several blade marks from cutting shingles during installation.

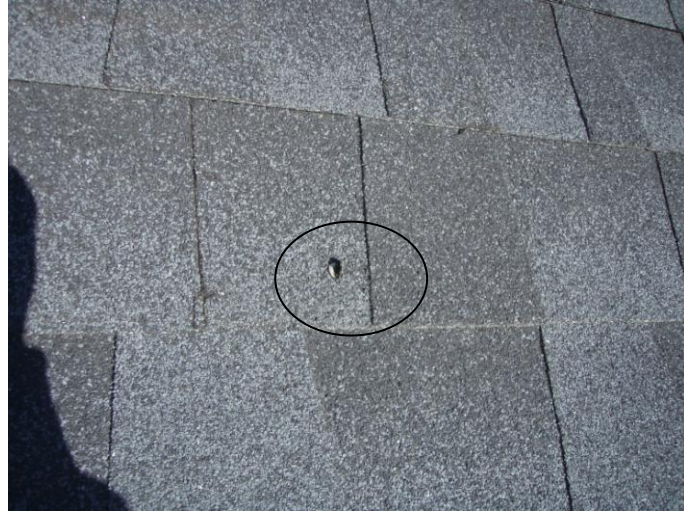
10. Nail pops, low nails and holes in shingles

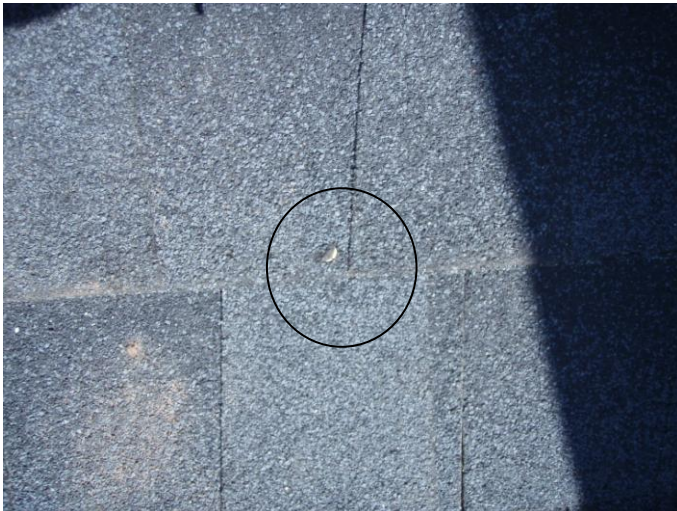
10. Nail pops, low nails and holes in shingles

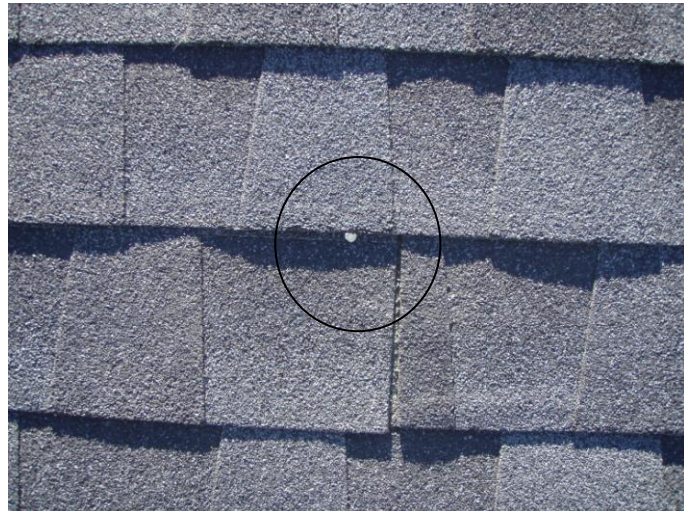
10. Nail pops, low nails and holes in shingles

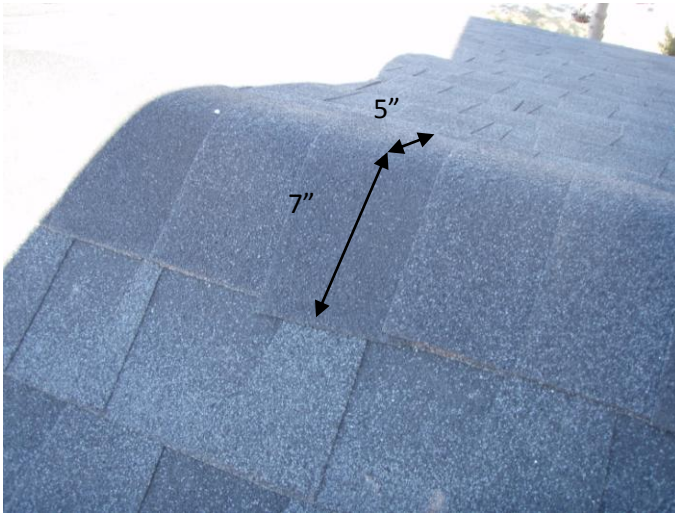
12. Ridge caps not installed with even coverage over both slopes.

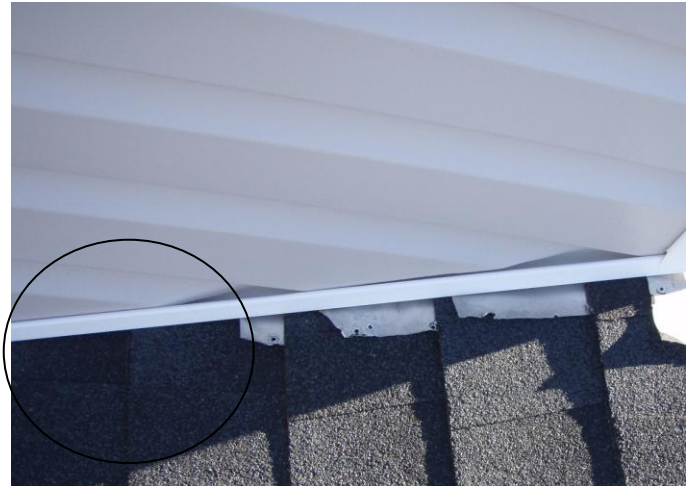
16. Improper size step flashing where new only has a 2" roof extension (PG 273 SLFG) Requires 5"x7" step flashing with 3" roof field projection

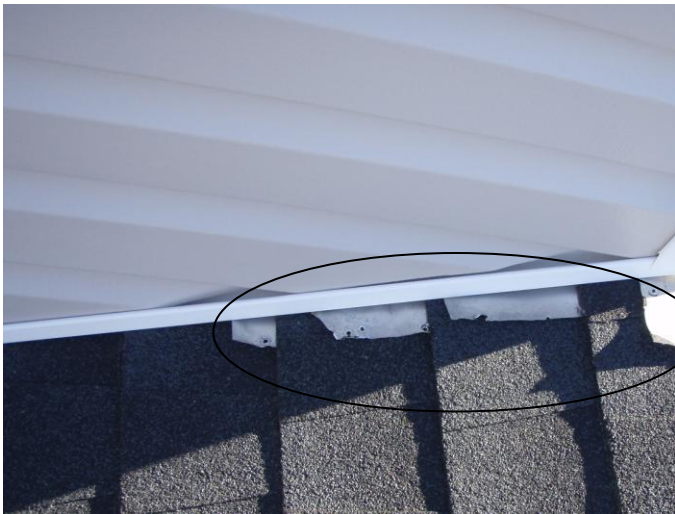
16. Old step flashing used and is in POOR condition in certain areas.

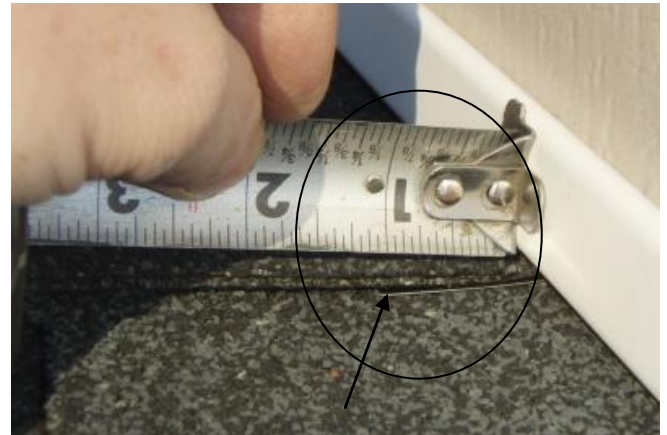
16. Step flashing is short and only extends 1" past J channel reflecting total of 2" on roof surface. (PG 273 SLFG) Requires 5"x7" step flashing with 3" roof field projection

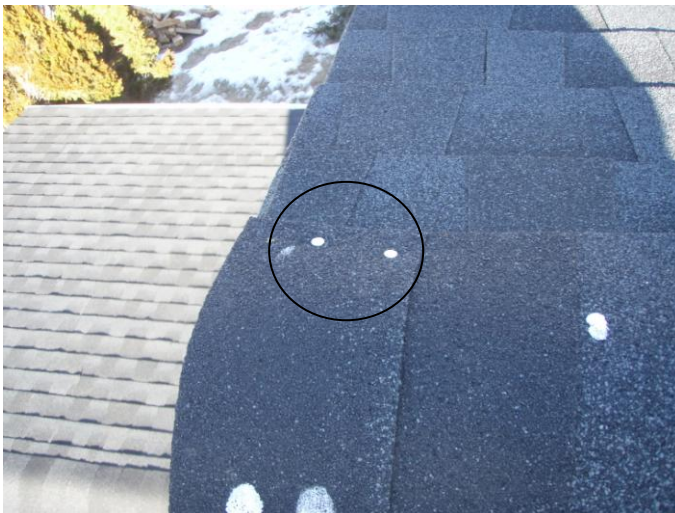
20. Exposed nail heads on several locations of the roof without proper sealant.

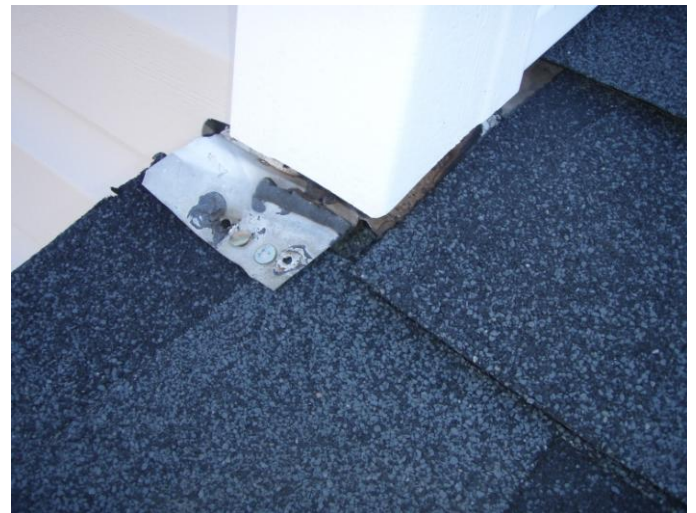
19. Existing apron flashing was re used and is in POOR condition.
