# Siding Inspection

**Orion Home Improvements**  
 8404 Harland Dr.  
 Springfield, VA 22152  
 Phone (703) 926-9824  
[Jdavis.roofing@gmail.com](mailto:Jdavis.roofing@gmail.com)

Fairfax, VA 22033	<b>CUSTOMER NAME</b>	Home: Work: Email:
-------------------	----------------------	--------------------------

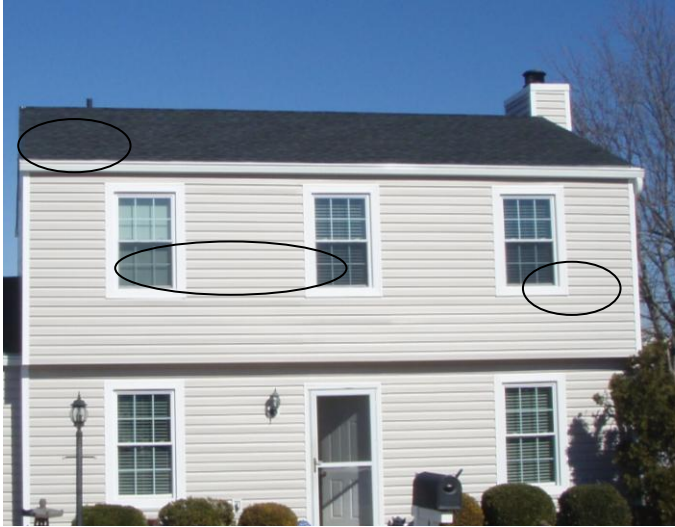
1. Siding buckled in appearance on front wall in these locations

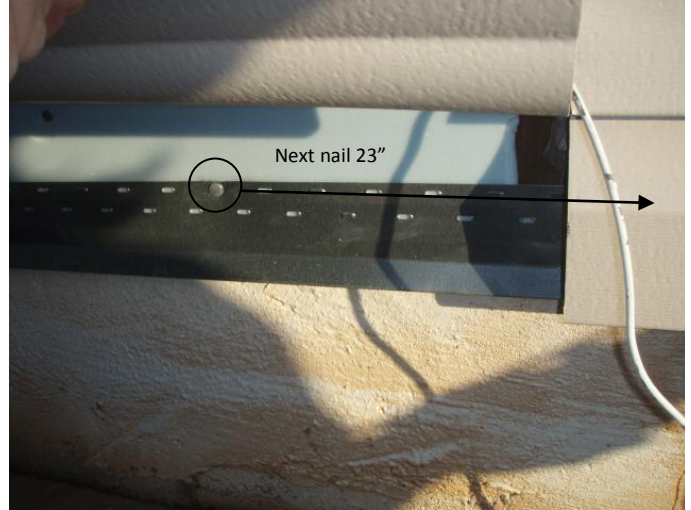
2. Starter strip not fastened properly at test location 23" OC. VSIIG Pg 19. Requires 10" OC

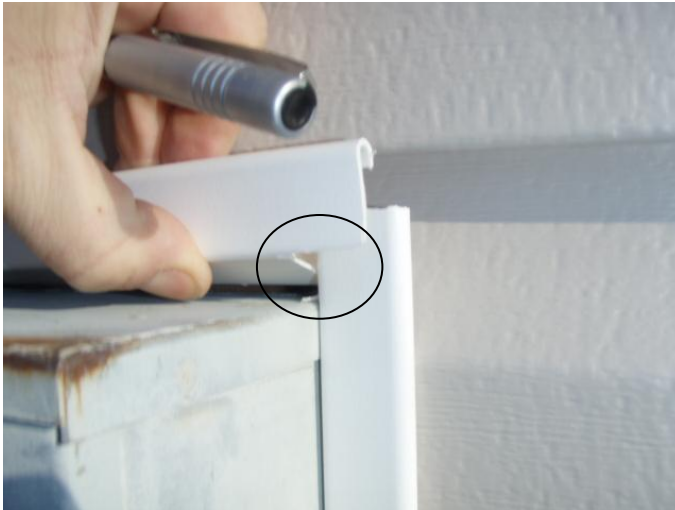
3. All J channel on home is missing Rain tabs and not sealed. VSIIG Pg 21 requires rain tabs

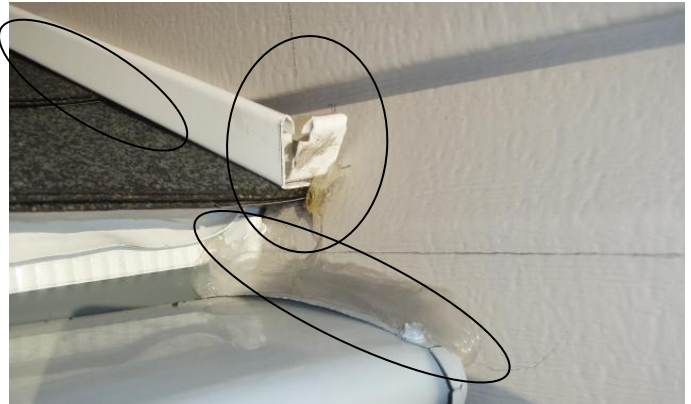
3. J channel does not have 1/2" clearance off shingles and there is no kickout flashing at the bottom termination. Excessive silicone installed with poor functionality and appearance. VSIIG Pg. 23 requires 1/2" gap Pg 25 requires kickout flashing.

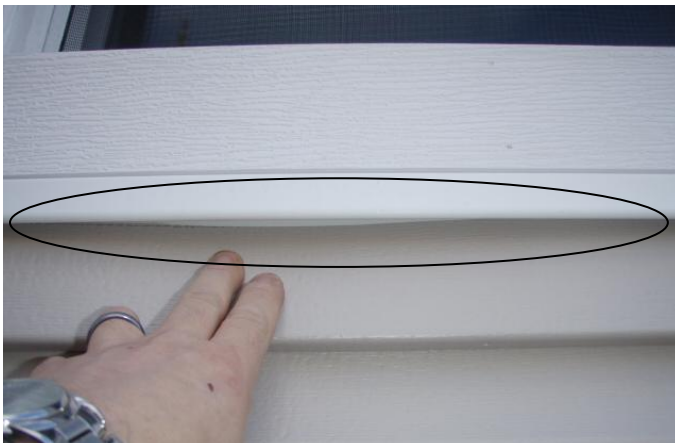
4. No undersill or utility trim is used to hold cut siding tight at top edge terminations. No snap lock lugs installed into siding panel. VSIIG Pg. 24, 25 requires undersill trim and snap lock lugs

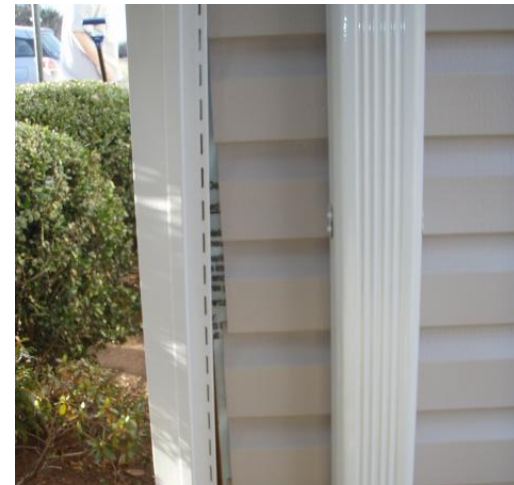
5. Outside corner post is NOT FASTENED AT ALL at this test location. VSIIG Pg. 18 requires 8 to 10 inch OC fastening of accessories.

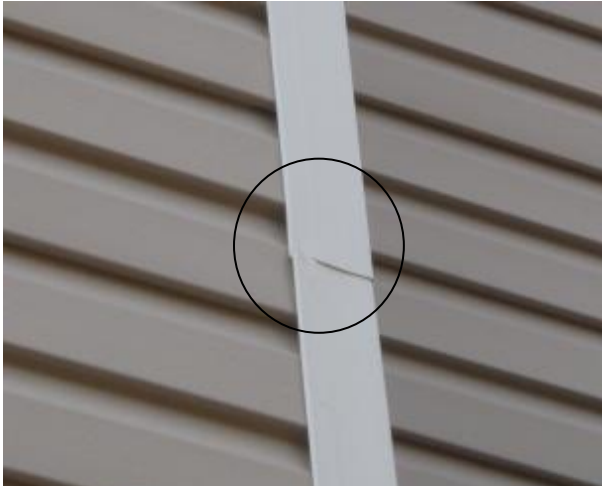
5. Outside corners improperly lapped at seams. VSIIG Pg. 18 requires  $\frac{3}{4}$ " overlap with 1" nailing flange cut away to avoid buckling.

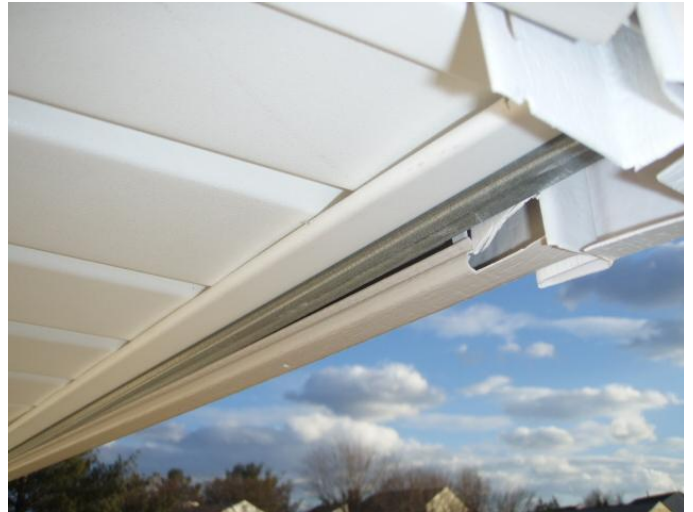
6. Siding panel not locked into starter strip.

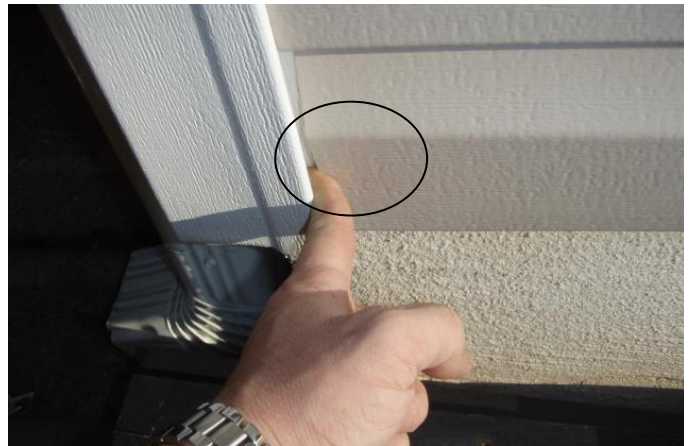
8. Siding cut too short for proper seat into the corner post. Adjustment not possible without opening overlap seam at other end. VSIIG Pg 23 requires  $\frac{1}{4}$ " clearance and 1" overlap

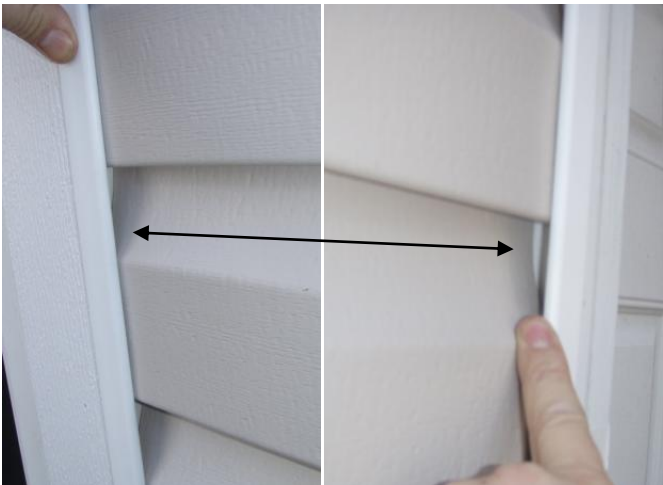
8. Both ends of this panel are tight against the pocket of the trim accessories not allowing for expansion and contraction of siding. VSIIG Pg. 23 requires  $\frac{1}{4}$ " clearance

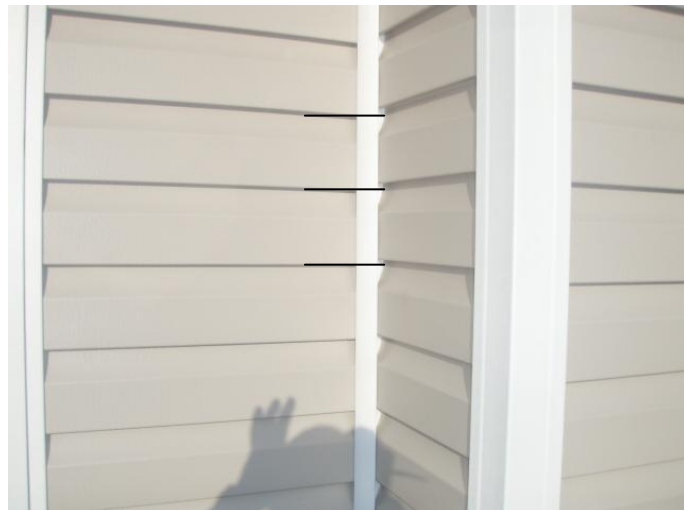
9. The courses at this inside corner are an example of not being aligned properly.

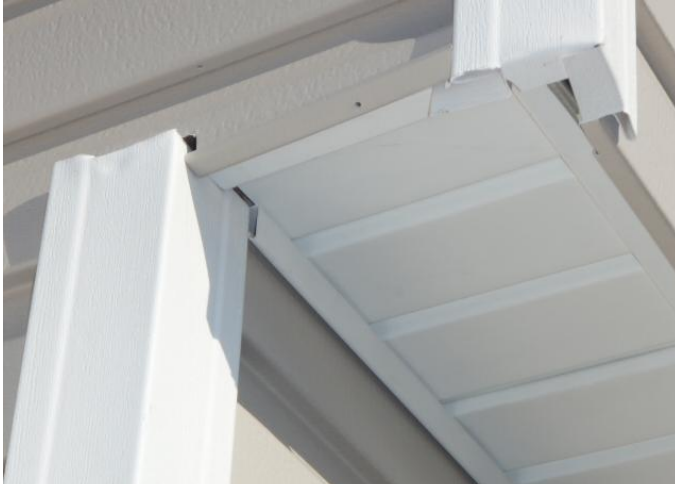
11/ 12. Soffit panels not properly secured and loose lay on top of siding receiver J channel. It does not have its own dedicated soffit F channel along the rear wall.

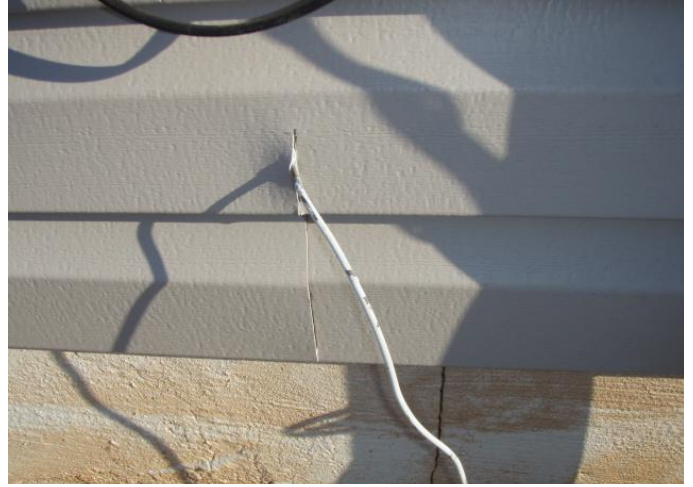
14. Siding is cut straight up leaving open to the elements. VSIIG Pg. 24 requires a new panel of siding be installed at the protrusion to allow for a proper seam.

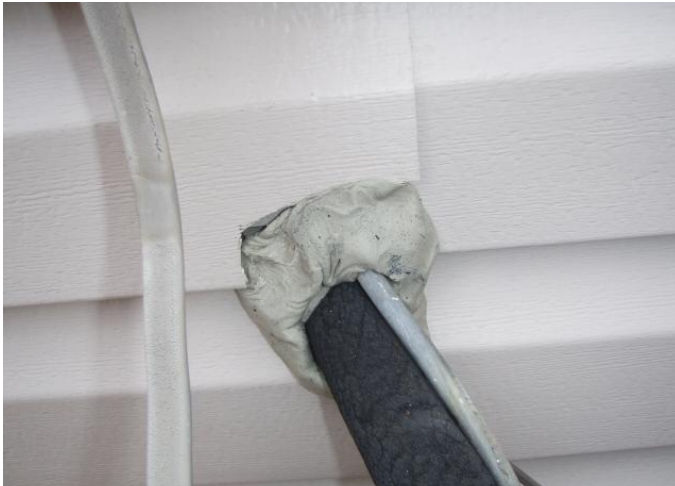
14. Siding cut too wide around this penetration. VSIIG Pg. 24 requires 1/4" gap around penetration with cut to follow contour of the penetration.

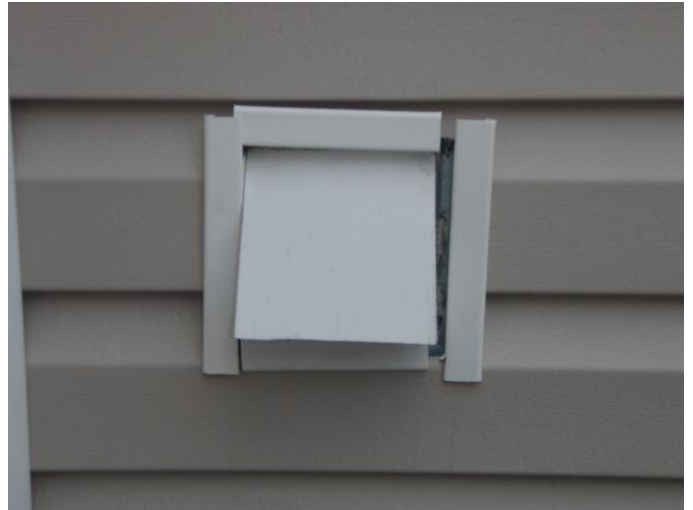
14. Existing vent trimmed out with J channel very poor installation will allow water behind siding.

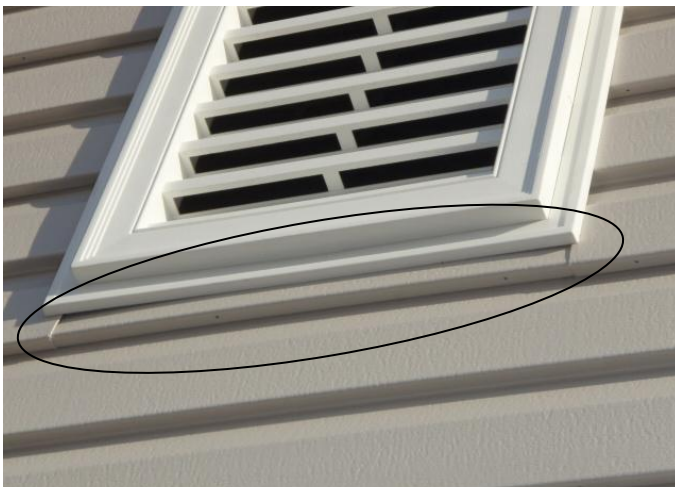
15. Siding not properly cut to fit around gable vent. New panel on each side of bottom edge with short cut scrap double seamed into the wall.

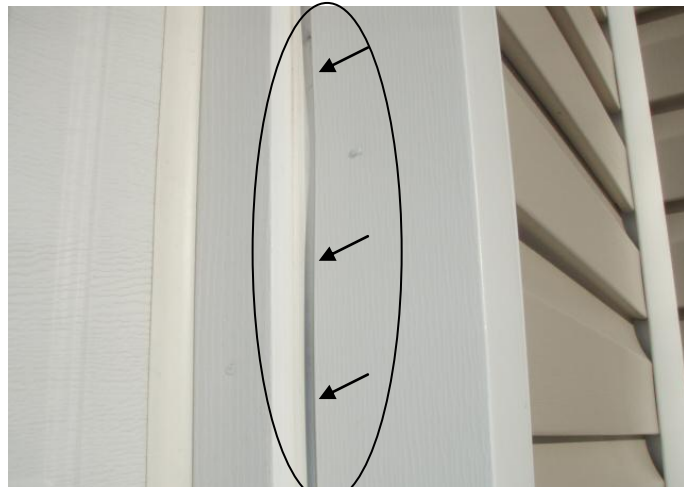
16. Custom aluminum trim capping around garage door is poorly installed, no stiffening breaks formed allows for oil canning with improper termination.
